Report No. 0270-07-17309

Testing and Examination of Pipe from
Dixie Pipeline Company's
12-inch Hattiesburg, MS to Demopolis, AL Pipeline

T. V. Bruno

March 30, 2007

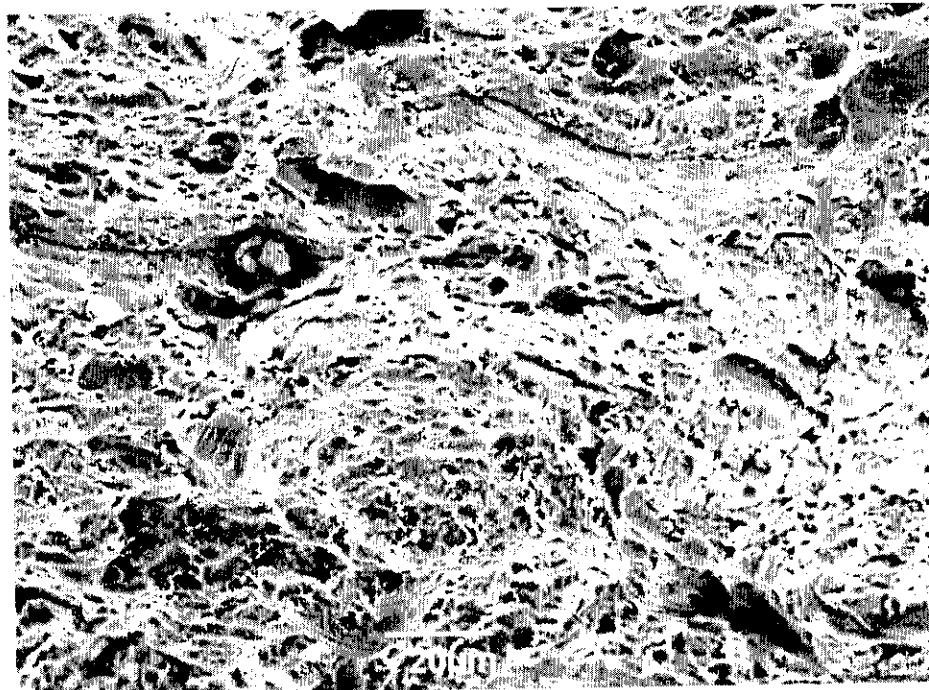
Figure 113 shows the area in the box at top, and Figure 114 shows the area in the box at bottom in Figure 112.

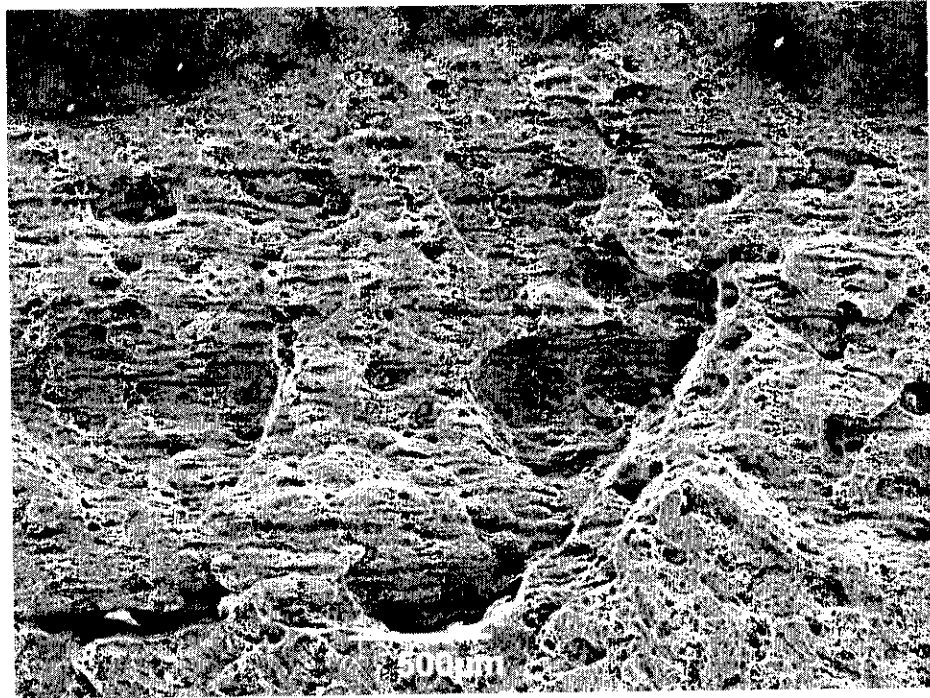
Figure 114

The appearance of the hook crack at top in Figure 136 was similar to that of the hook crack shown in Figure 114.

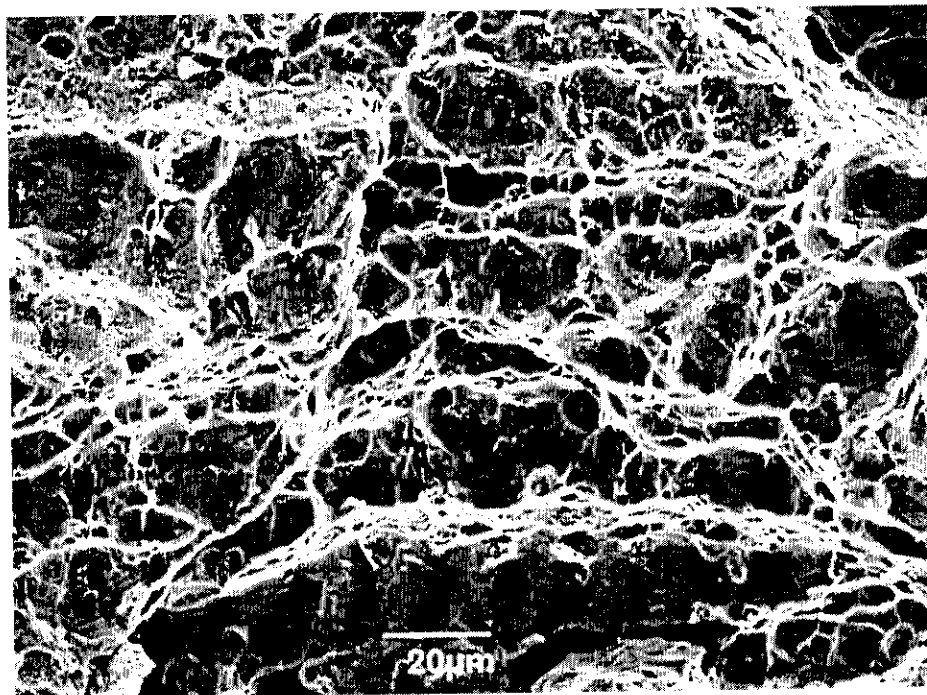
Figure 115 shows a large area of woody fracture, and Figure 116 shows a typical location at higher magnification.

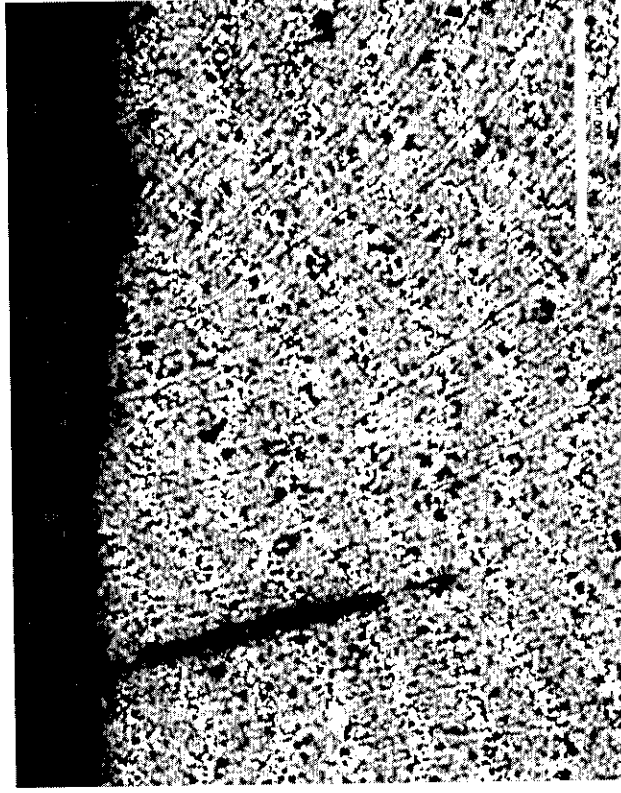
Figure 122 Joint No. 10737 25X Nitral Etch

Views at two magnifications of a transverse section across one of the magnetic particle indications shown in Figure 121.

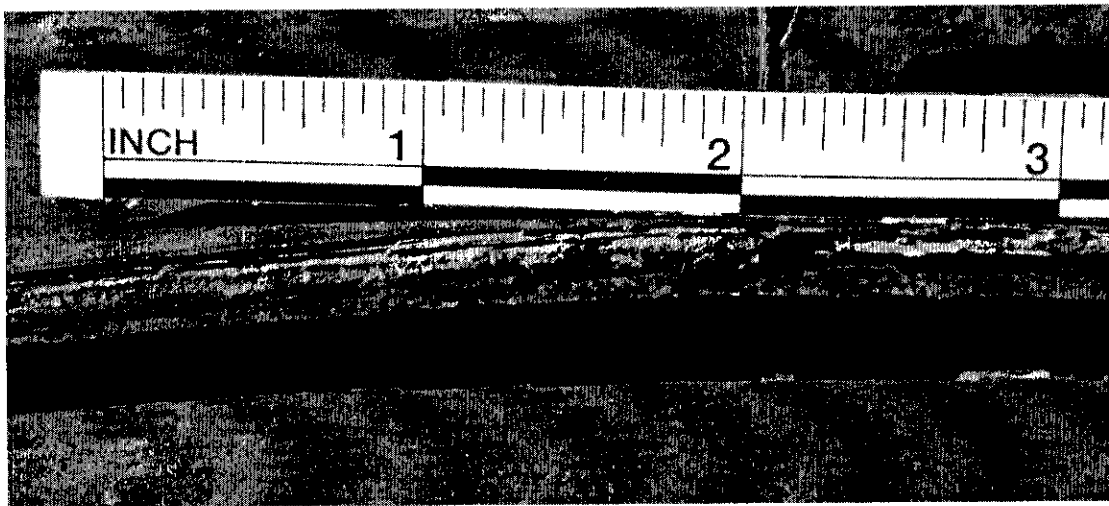
Figure 127

The fatigue-test rupture in Joint No. 10737 was 3 feet, 8 inches long, and extended from 46 feet, 8 inches to 50 feet, 4 inches, which was not a location with reported inspection indications. Figures 126 through 128 (provided by SES) show the fracture immediately after testing. Note that the downstream end is at left in Figures 126 through 128. The appearance of the fracture surface indicated that the failure started at large hook cracks.

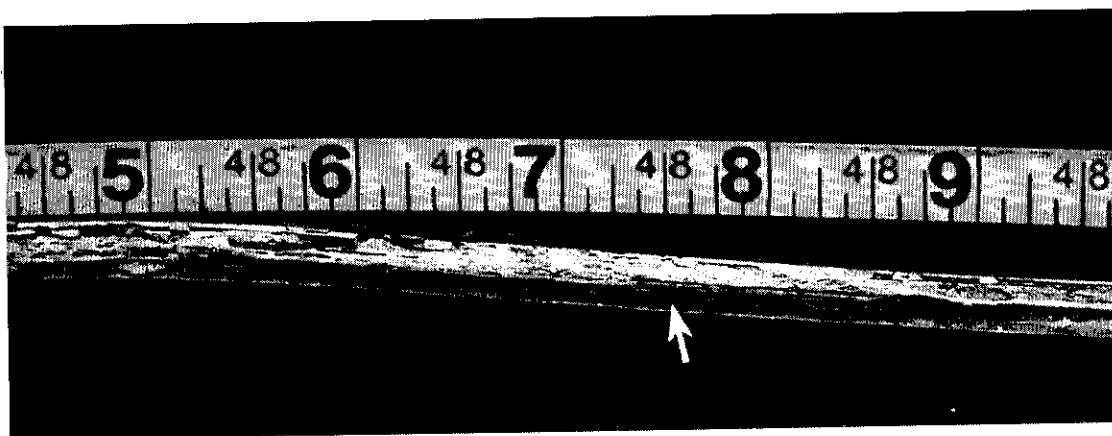
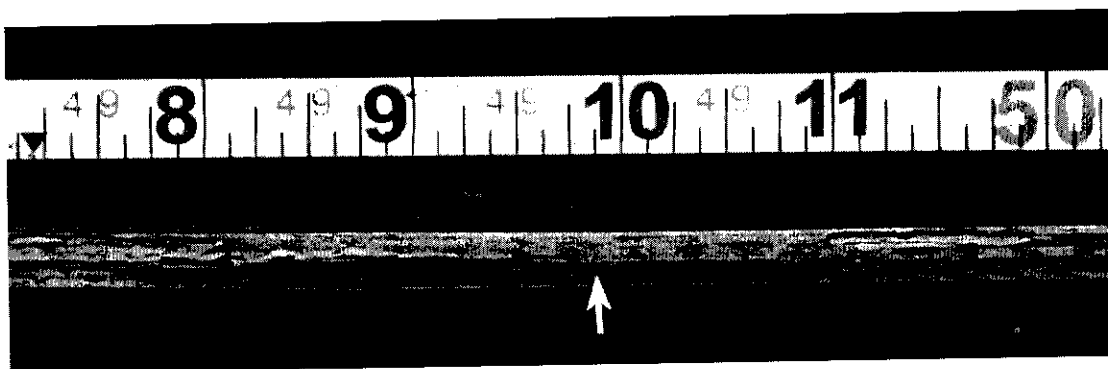
We cut the fractures from the pipe, cleaned them and examined them visually. The failure appeared to have originated near the middle of the rupture at a large hook crack on the inside surface that was continuous for almost the full length of the rupture. Figures 130 and 131 show part of the hook crack near the middle of the rupture, and Figure 132 shows the hook crack near the downstream end. The hook crack was 0.07 inch deep, or 24 percent of the wall thickness near the middle of the rupture, and 0.11 inch deep, or 41 percent of the wall thickness at the location shown in Figure 132. The fracture appearance toward the outside surface was indicative of smaller hook cracks.

Two views of the hook crack, arrows, near the middle of the rupture.

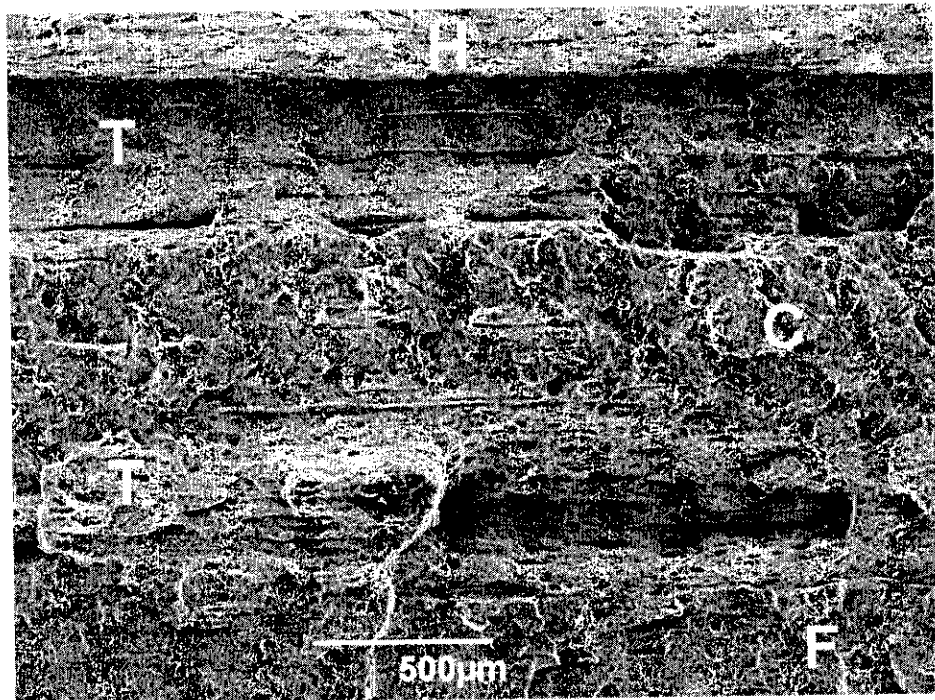
We examined the fracture surface carefully for evidence of fatigue. Two areas of bright, flat fractures with possible fatigue indications were found and examined in an SEM. Bright surfaces are indicative of relatively fresh fractures, as opposed to dark areas that represent prior flaws. The first area was found to be all cleavage fracture. The second area showed a narrow band within the area of bright fracture with steps across the fracture surface that were suggestive of fatigue. Figures 133 and 134 show part of the second area, which was centered at 48 feet, 9 inches, with arrows indicating the bright band with possible fatigue markings. Figure 135 shows the fracture at higher magnification; the fresh fracture does not appear bright because the micrograph was taken in the SEM. The longitudinal lines within the band indicated by the arrows were not seen elsewhere on the fracture.

Electron micrograph with arrows indicating the band with possible fatigue markings.

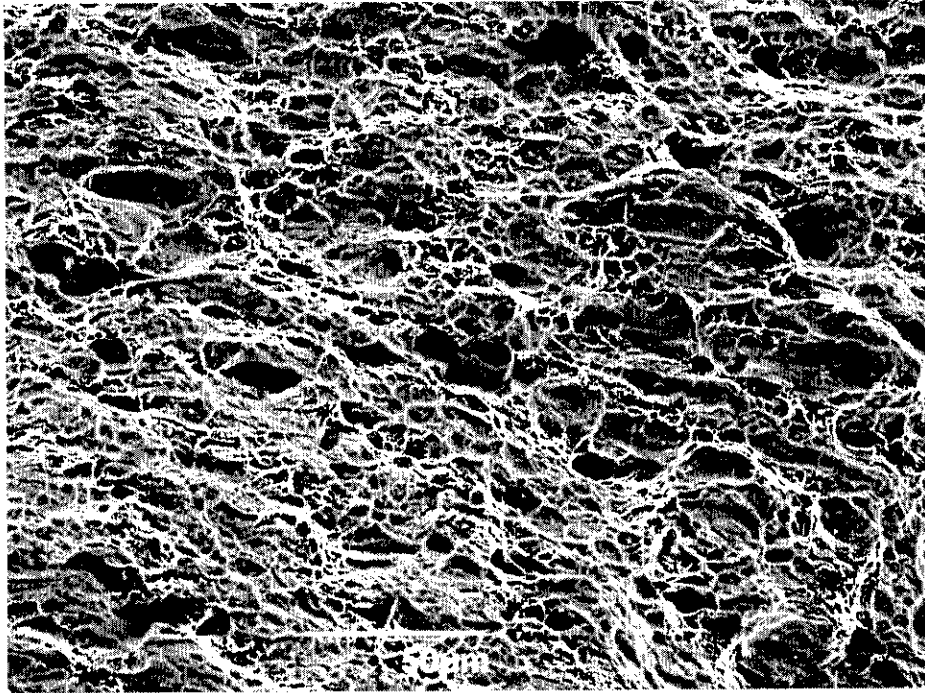
Figure 138

Views at high magnification of fatigue indications, some of which are indicated by arrows, at two locations within the band indicated by the arrows in Figure 135.

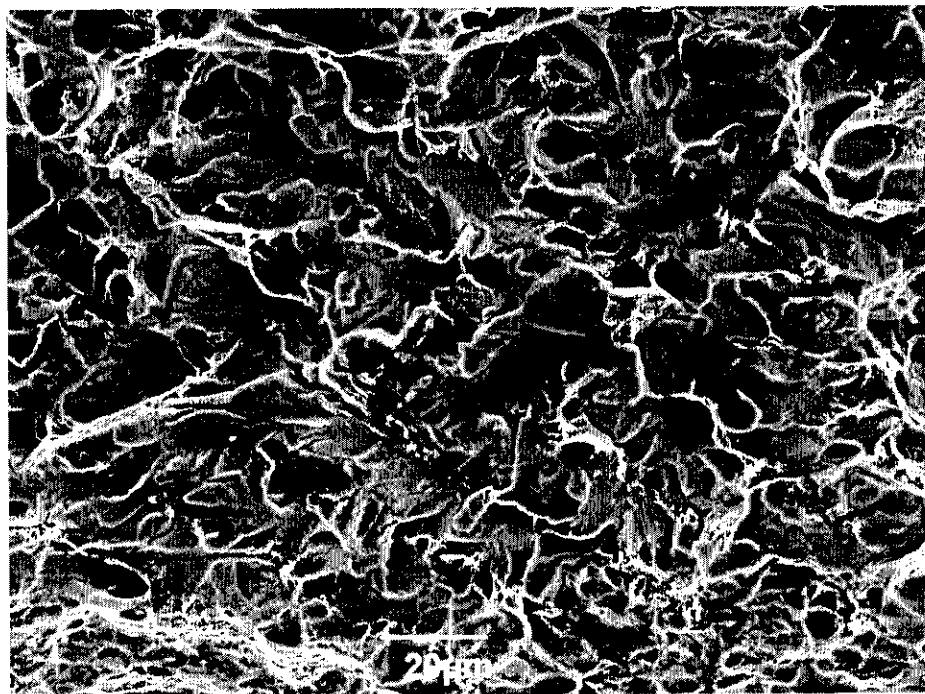
Figure 139

Figures 139 and 140 show representative areas of tearing and cleavage, respectively.

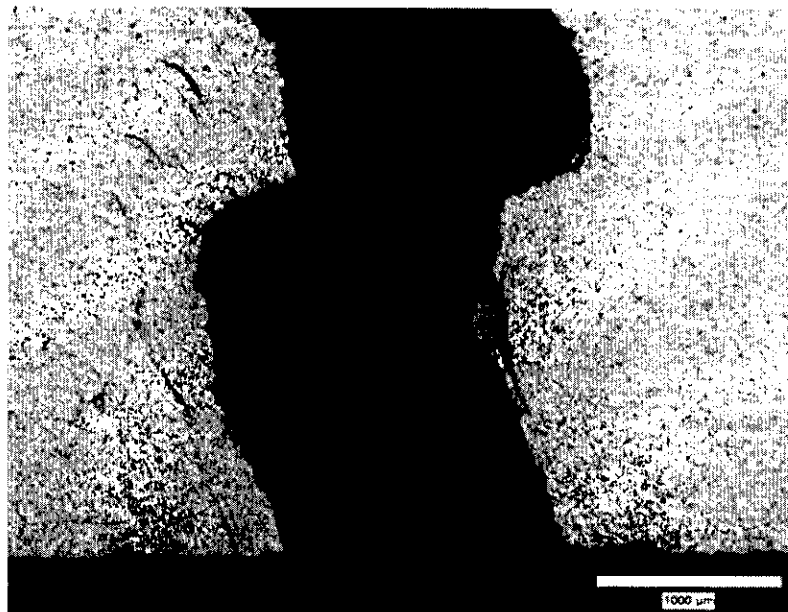
Figure 141 Joint No. 10737 8X
Nital Etch

Matching transverse sections were taken from each side of the fracture at the location shown in Figure 134, and prepared for metallographic examination. Figure 141 show the sections after polishing and etching, with a large hook crack evident at the inside surface, smaller hook cracks at the outside surface and flat fracture in between. Figures 142 through 144 show the large hook crack at the inside surface at higher magnifications. There was scale along the surface of the hook crack, indicating it originated during manufacture of the pipe. As shown in Figure 143, the fiber lines on one side of the weld were very irregular, which is indicative of offset skelp edges during manufacture.

Matching transverse sections from the middle of the fracture shown in Figure 134.

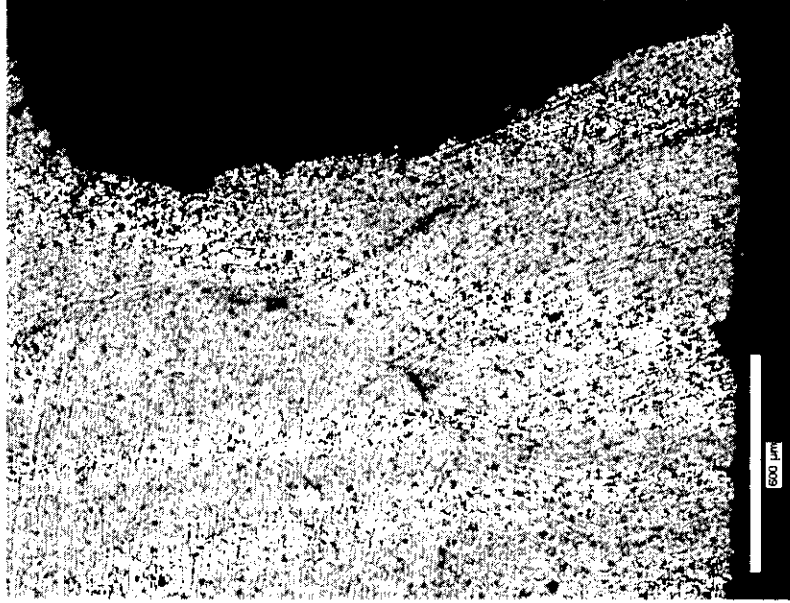
Figure 142 Joint No. 10737 25X
Nital Etch

View of the hook crack at the inside surface.

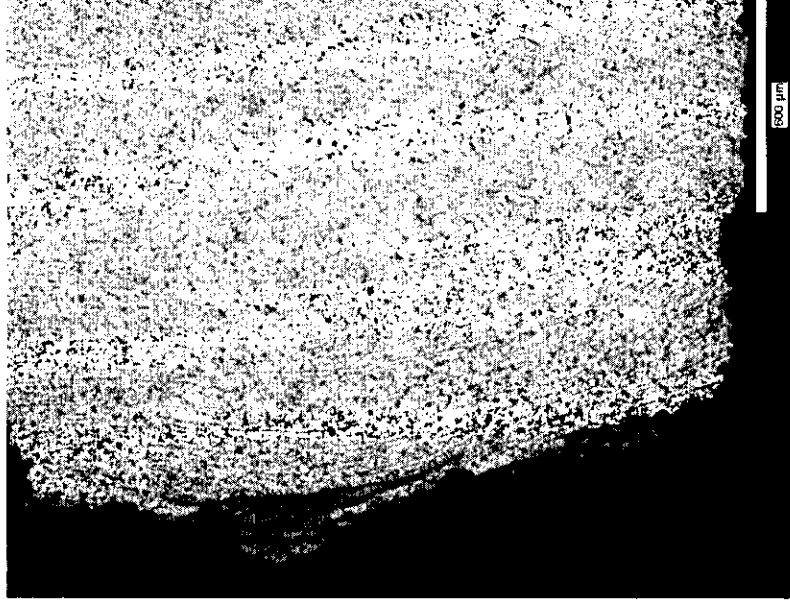
Figure 143 Joint No. 10737 50X

Views of the hook crack at higher magnification. Note the irregular fiber lines in Figure 143.

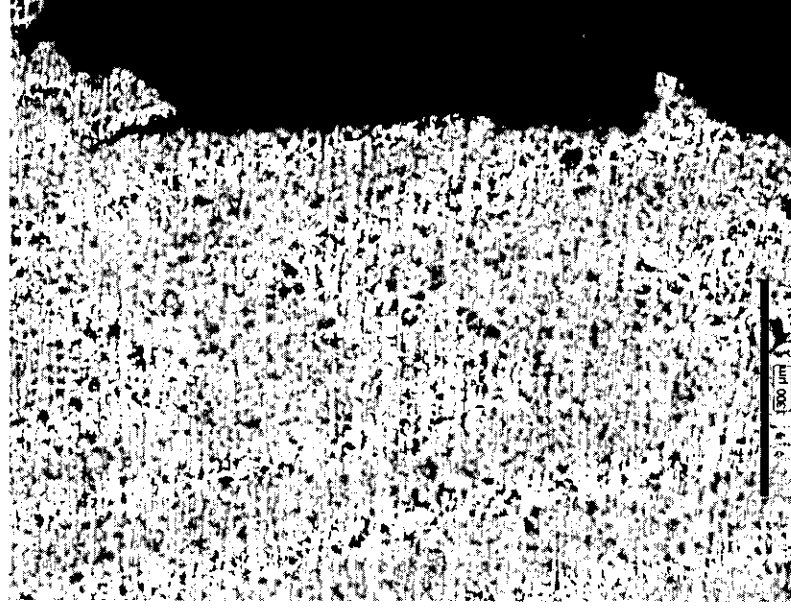
Joint No. 10737

Figure 145 shows the fracture near midwall, which includes the flat area that was examined in the SEM, arrow, and Figure 146 shows the flat area at higher magnification. The flat, straight fracture is consistent with, but not necessarily indicative of, fatigue.

Figure 145 shows the fracture near midwall with an arrow indicating the flat fracture examined in the SEM, and Figure 146 shows the flat fracture at higher magnification.

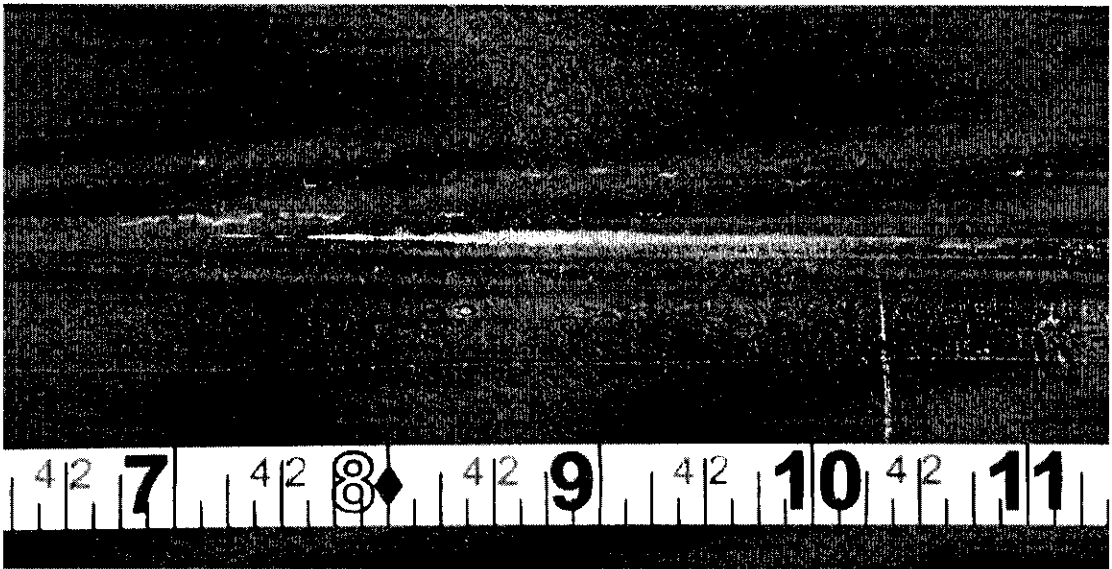
The reported Manual and PAUT inspection indications were downstream of the rupture, and were covered with Polyguard wrap. The wrap was removed and the weld at those locations was inspected with magnetic particles. We found a number of straight, discontinuous indications similar to those shown in Figure 111. Figure 147 shows a location with the heaviest magnetic particle build up, which is shown in closer view in Figure 148. A section for metallographic examination was taken from the location of heaviest particle build-up. As shown in Figure 149, the indication was caused by a hook crack that was approximately 0.02 inch deep. There was no evidence of fatigue crack extension from the hook crack.

Figure 147 shows magnetic particle indications along the fatigue-test section of Joint 1037 down stream from the rupture, and Figure 148 shows the heaviest magnetic particle build up.

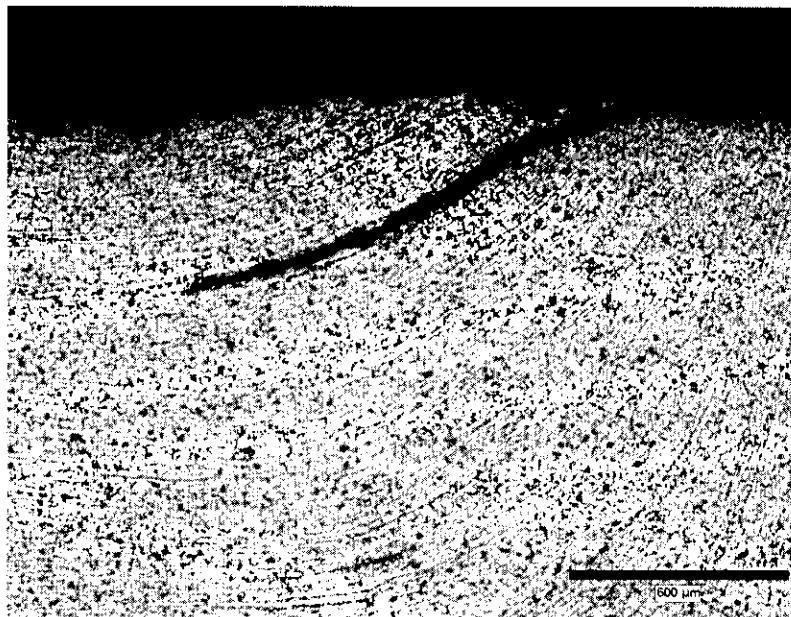
Figure 148

Section taken from the magnetic particle indication shown in Figure 148, showing that the indication was caused by a hook crack.

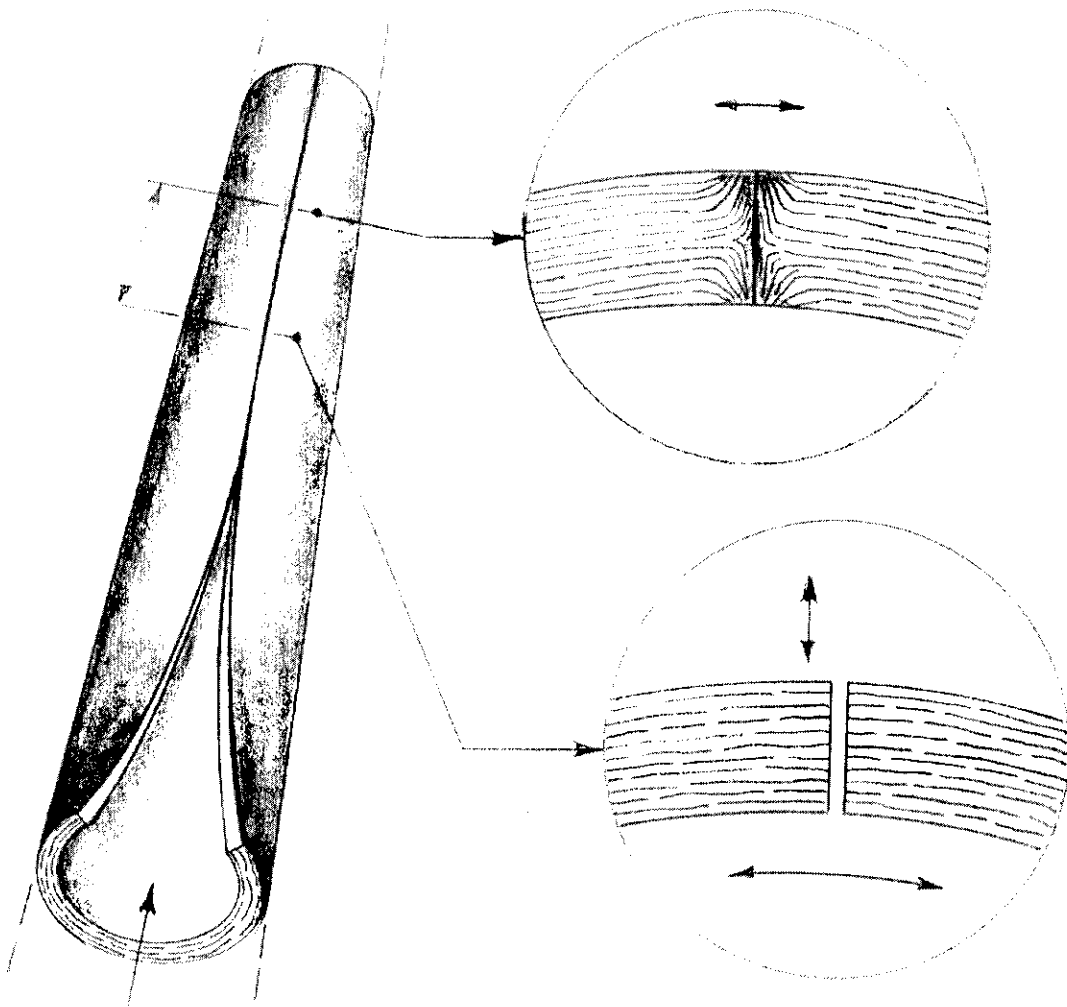
Figure 151

across the converging edges, and forcing the abutting edges together, as illustrated in Figure 151. For low frequency electric-resistance welding, the current was introduced by copper electrode wheels on each side of the weld. Because heating of the skelp edges oxidized the surface layers, the edges had to be brought together with sufficient force to extrude all the oxidized metal, called "flash", and form a pressure weld in sound metal. The flash was then trimmed from each surface. Insufficient force could lead to a weak weld or to entrapped flash along the weld line. Pre-arcing of the abutting edges prior to convergence could cause oxidation that prevented subsequent fusion and lead to un-welded "black spots". Arcing between the welding electrode and the outside surface of the pipe caused contact marks, which normally were less serious than other types of flaws.

Schematic illustration of electric-resistance welding.

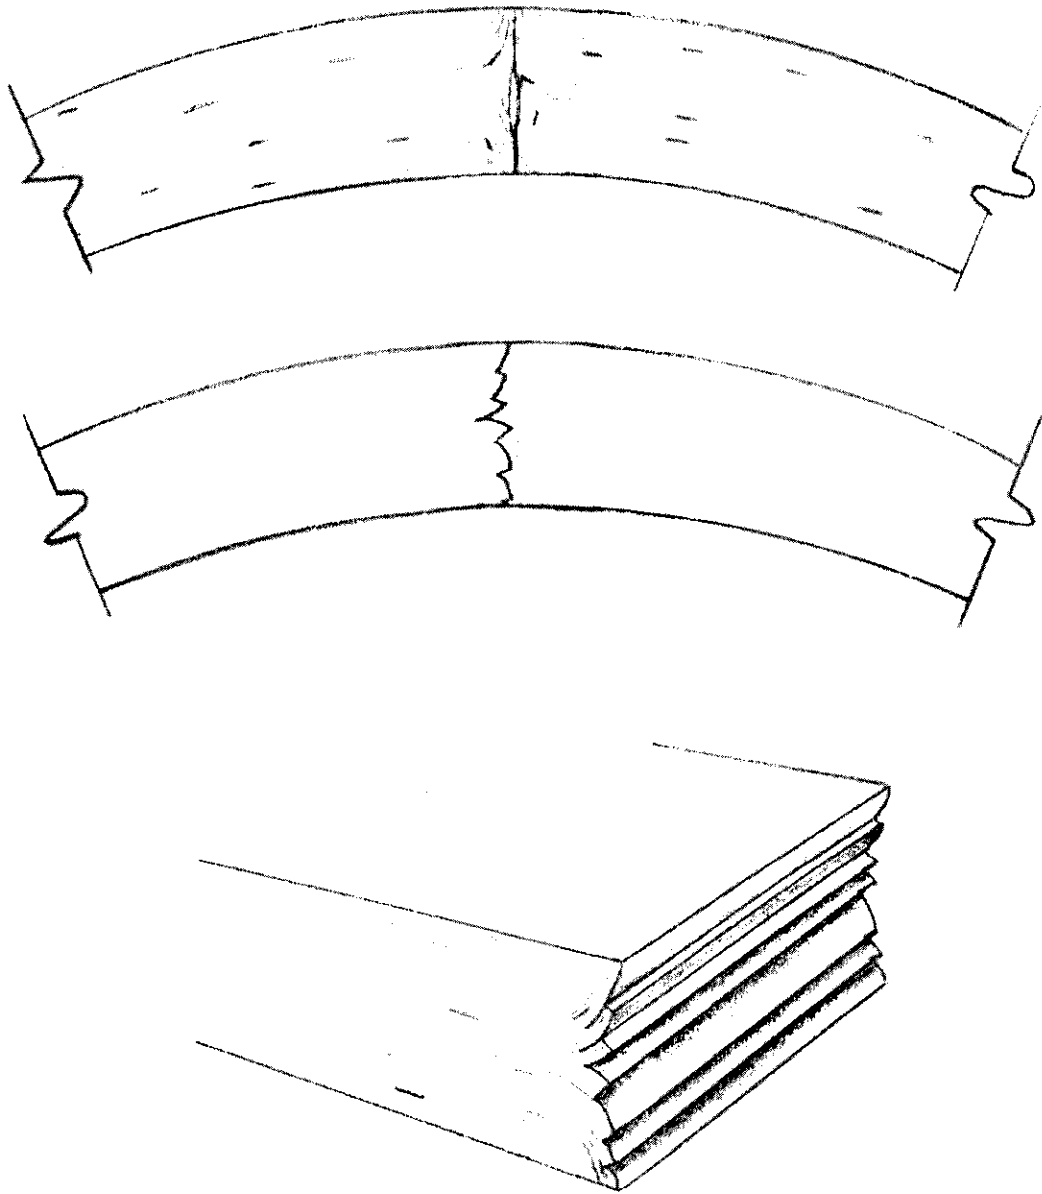
Figure 152

One of the most common flaws in older electric-resistance welded pipe, and the most common found in the 21 test joints, are hook cracks. When the abutting edges are brought together, the fiber lines in the skelp are bent toward the outside and inside surfaces, as illustrated in Figure 152. The change in direction at the weld creates a weak plane, similar to the z direction in the skelp. The properties in this plane depend on the amount of segregation and, particularly, the number and size of nonmetallic inclusions in the steel. Depending on the properties of the skelp, how the pipe is formed, how the skelp edges are prepared and other factors, separations may develop along the up-turned and down-turned fibers during manufacture. In addition, separations may develop along the fiber lines from the stress caused by internal pressure. In either case, the separations are called hook cracks. Scale from the heat of welding can sometimes be found on the surface of hook cracks, which shows they formed during manufacture. Often, however, no scale is apparent, and it is not clear whether the hook crack formed during manufacture or subsequently due to stress across weak fiber lines.

Schematic illustration showing how the fiber lines are bent at the weld.

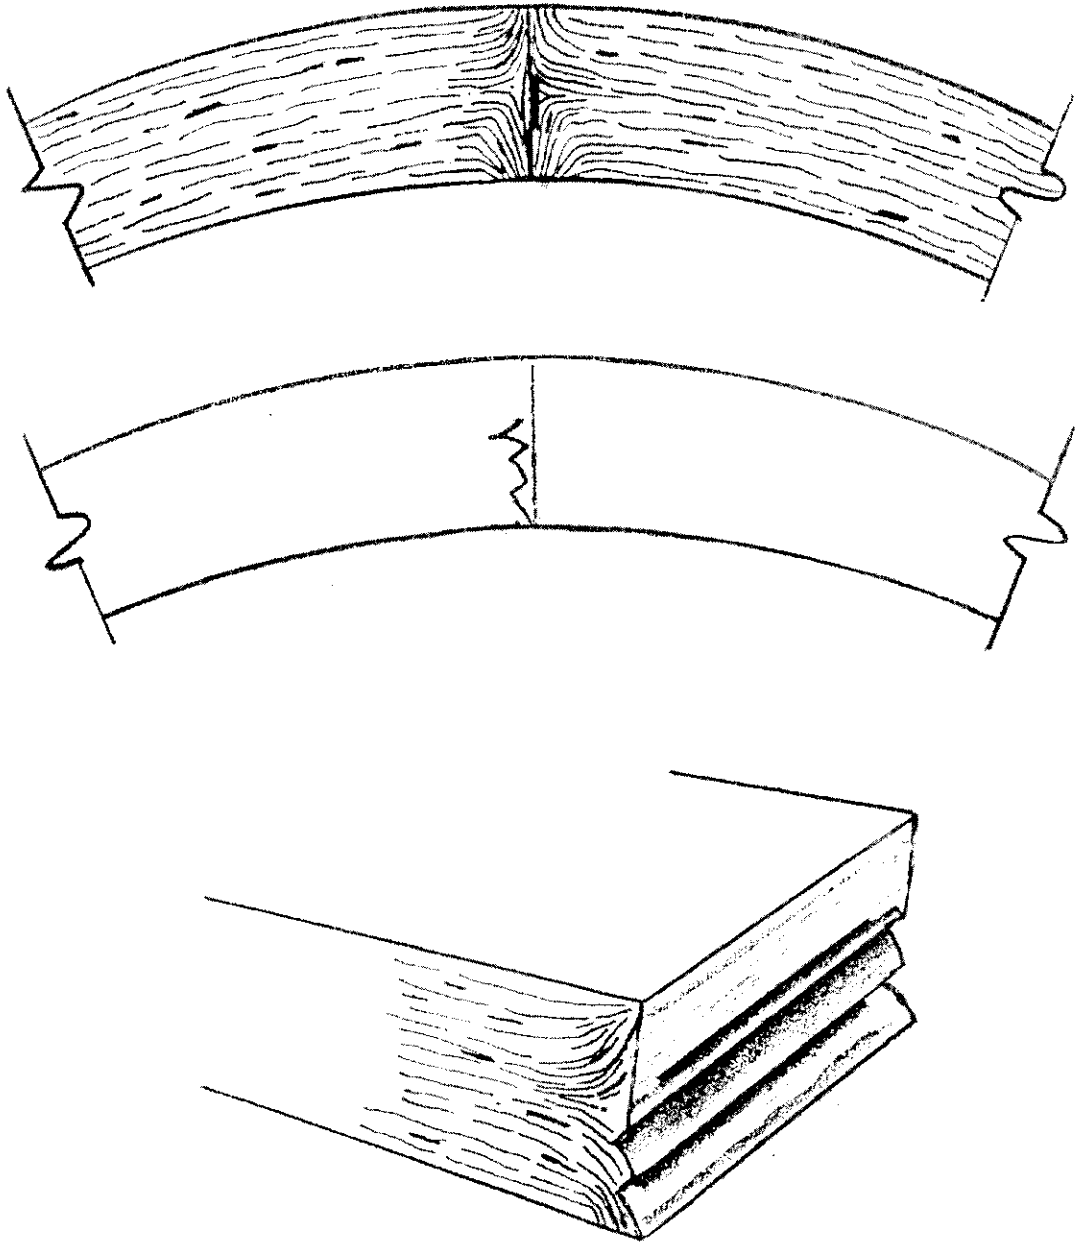
Hook cracks are identifiable on fracture surfaces because of the curved separations. Figure 153 illustrates a fracture surface with hook cracks across the wall, and Figure 154 illustrates a fracture with partial hook cracks.

Schematic illustration of hook cracks across the wall thickness.
